# Manhole Inspection Summary

Manhole # S59K\_\_007MH

Insp Date: **7/24/08 8:04 AM**

**Location** Address: **4500 fait ave**

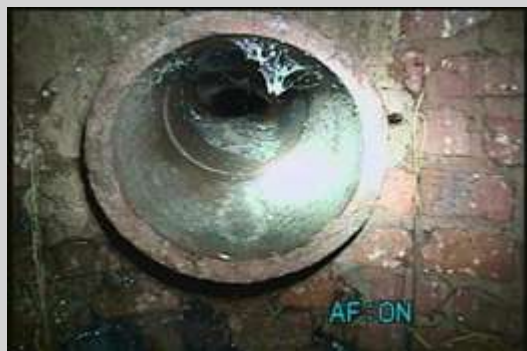
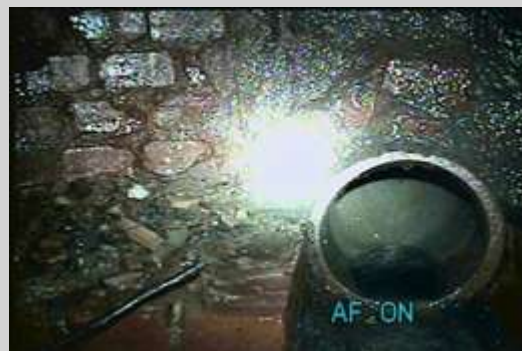
9 O'Clock Inflow

8 in. Circular Gravity Sewer

Pipe In @ 9 O'Clock

Drop In @ 9 O'Clock

Infiltration: **None** Pipe Seal Cond: **Unknown**

Drop Condition: **Open**
